PERATION

GREENHOUSE

SCIENTIFIC DIRECTOR'S REPORT

ANNEX 3.2 U. S. NAVY STRUCTURES

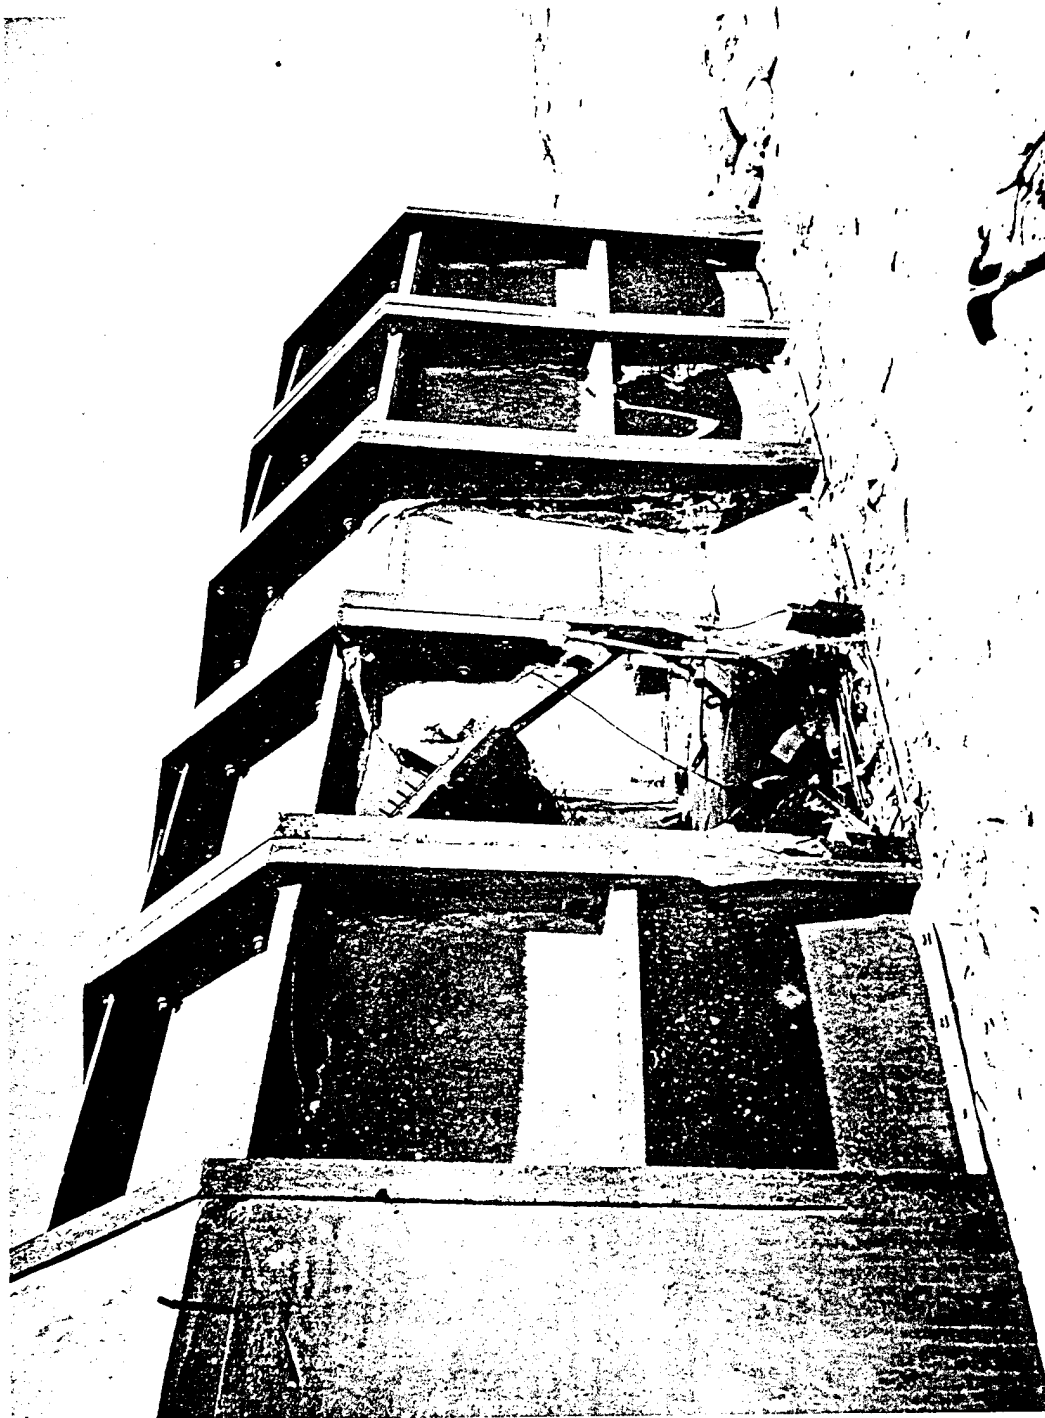
Fig. L. 351 View of Right Front-wall Panels Showing Damage Gradation from Right End, Structure 3. 2. 4b

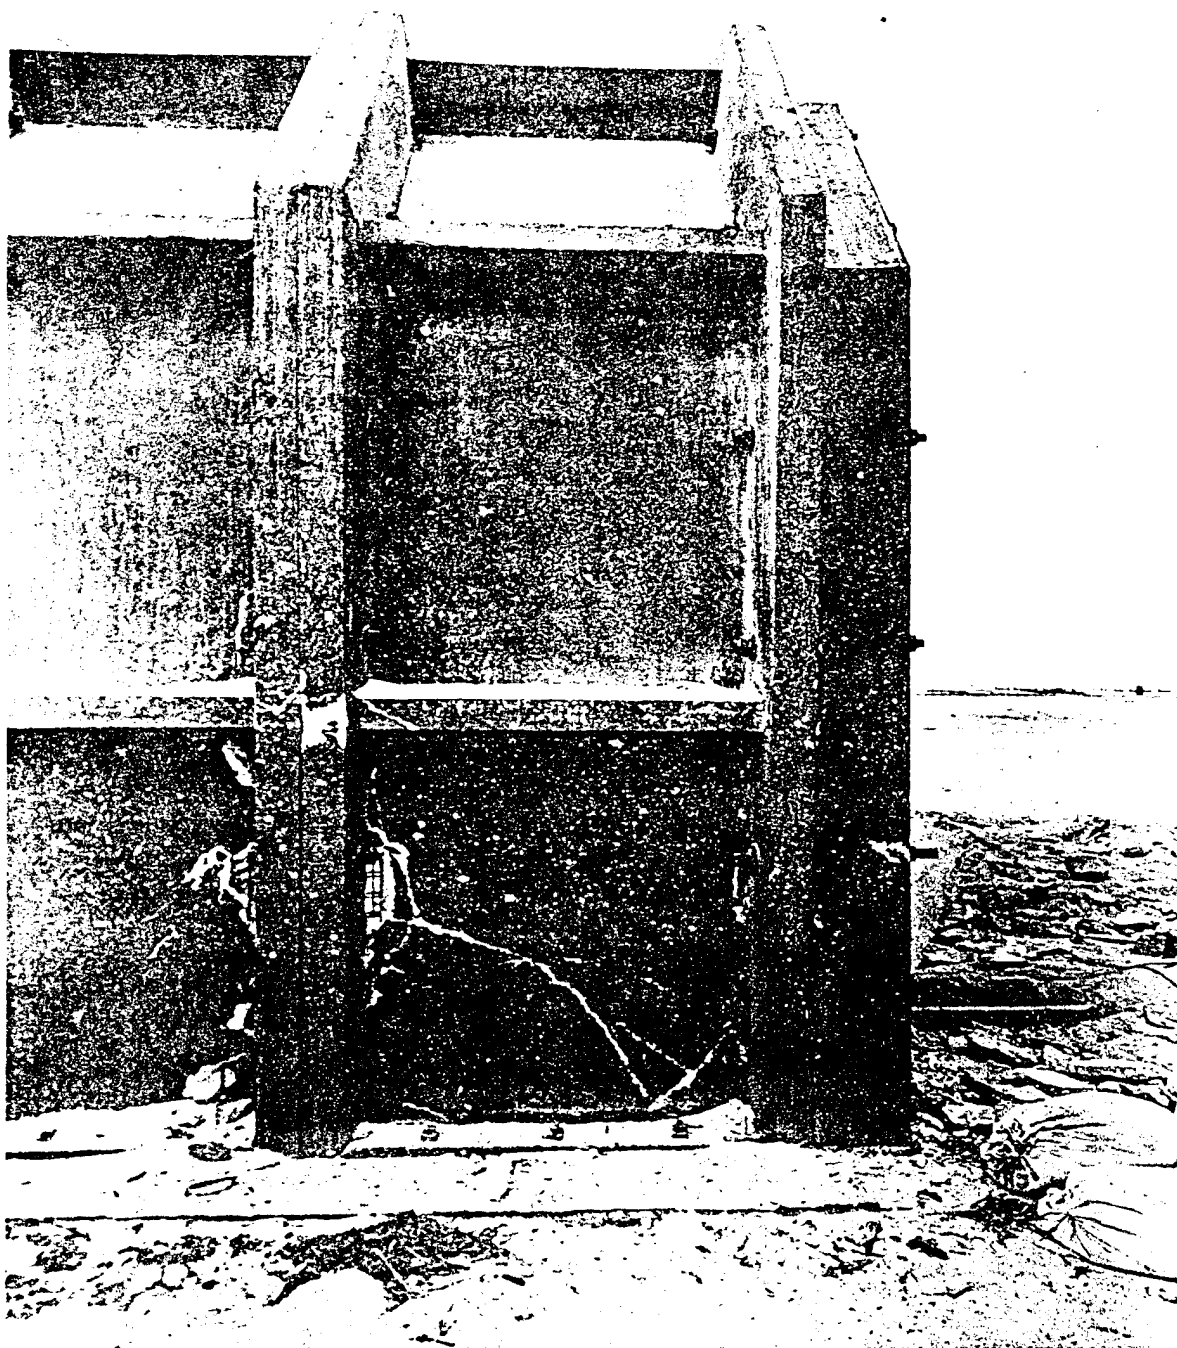
Fig. L.352 Exterior View of Ribs-out Panel Adjacent to Right End of Structure, 3.2.4b

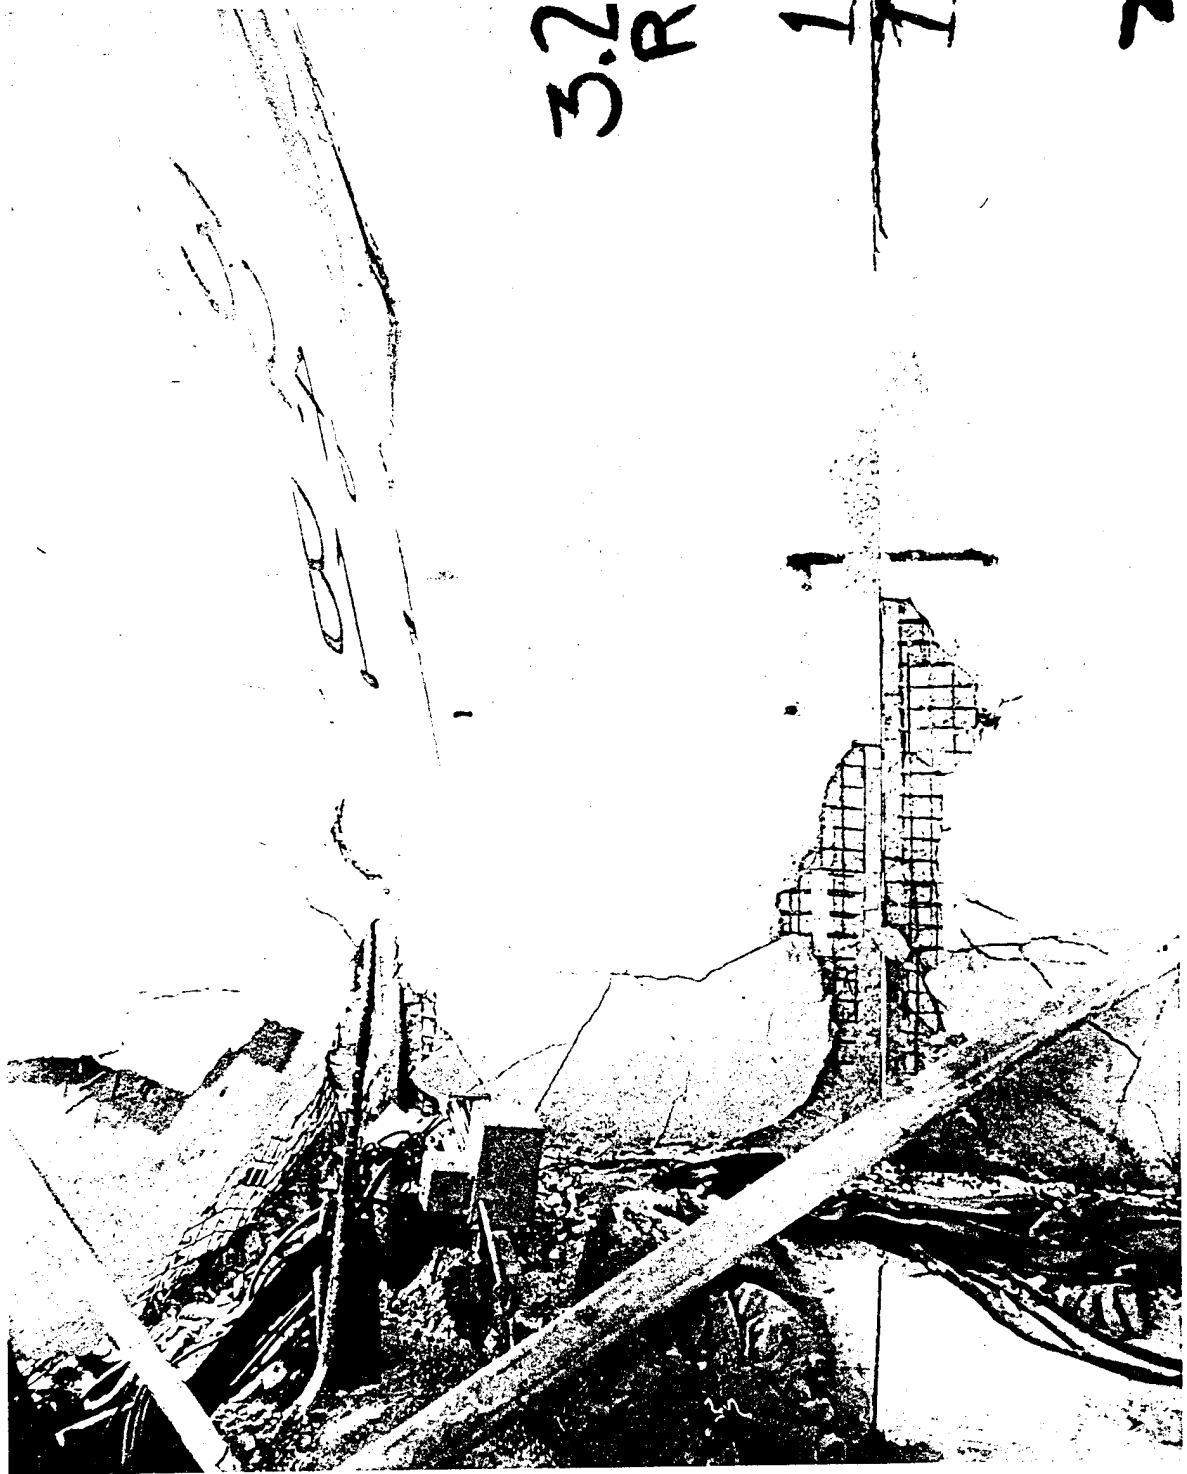
Fig. L. 353 Interior View of Ribs-out Panel Adjacent to Right End of Structure, 3.2.4b

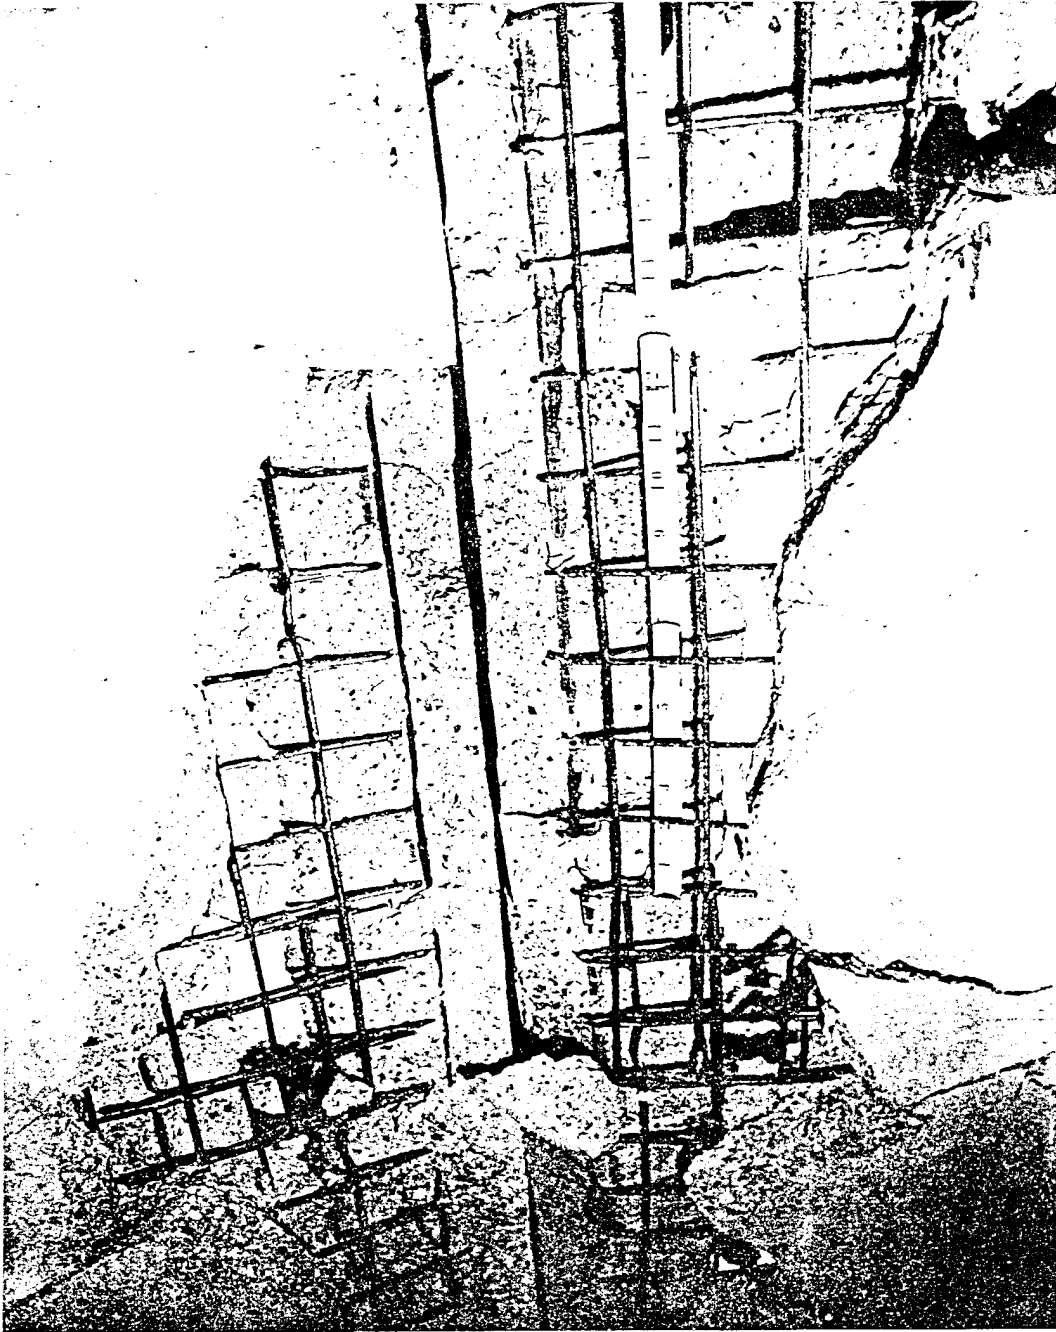
Fig. L. 354 Interior Detail of Concrete Spalls at Edges of Panel Adjacent to Right End and the Adjacent Wall Panel,
Structure 3.2.4b

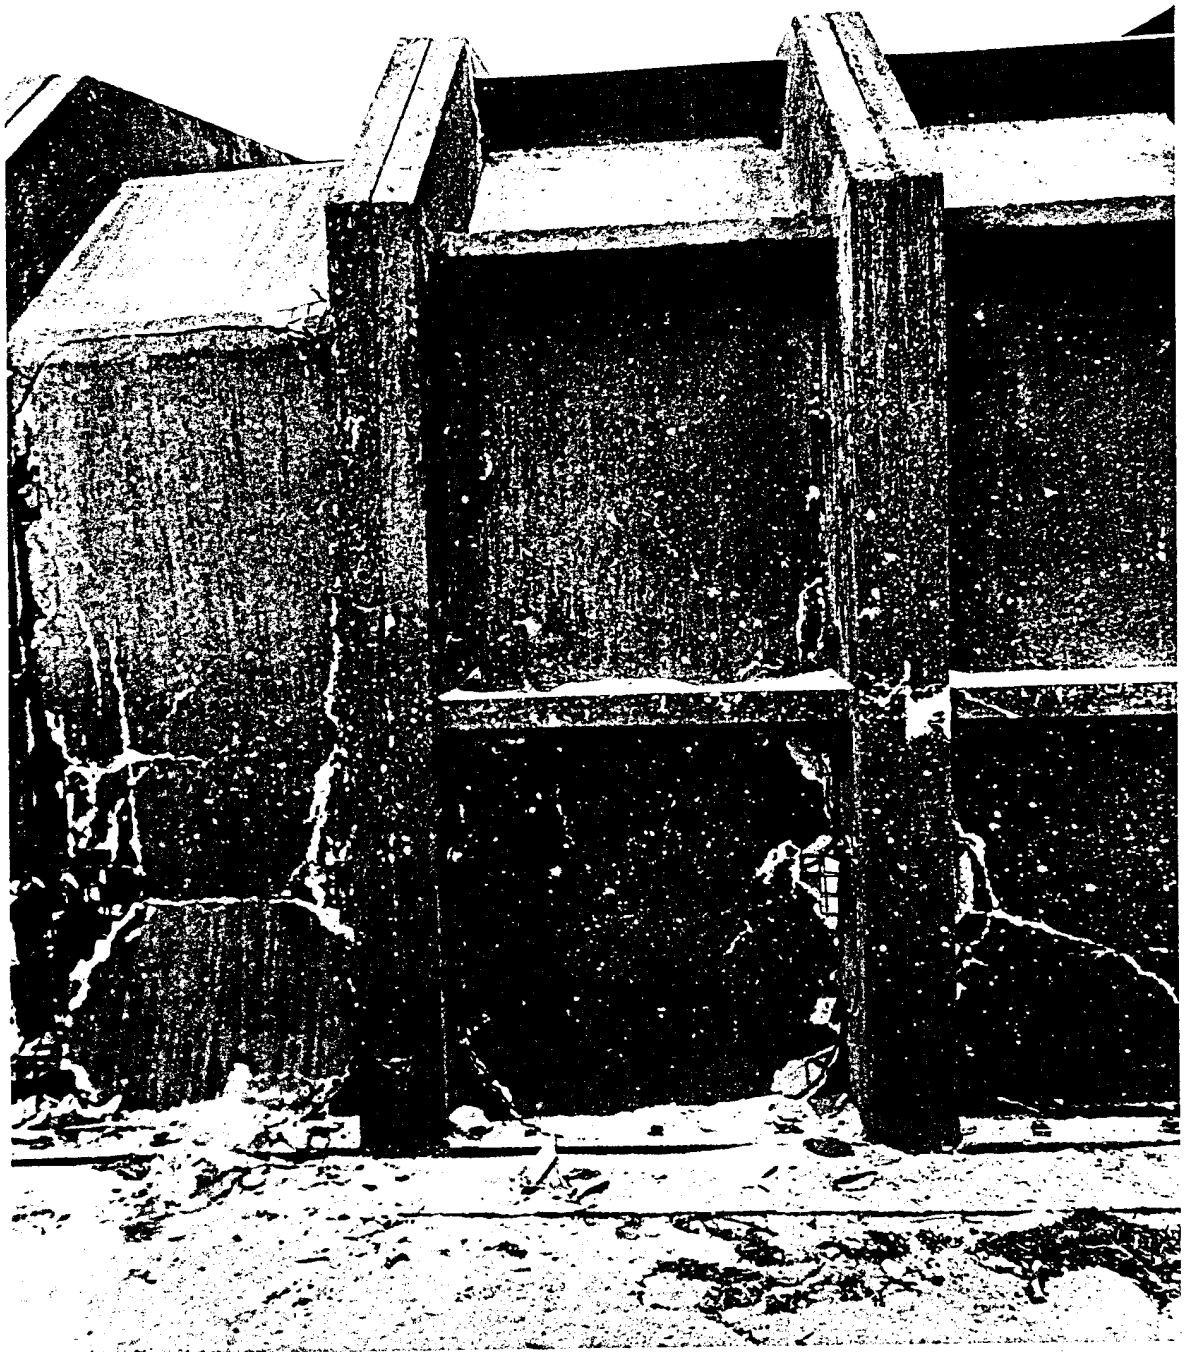
Fig. L.355 Exterior View of Ribs-out Panel Second from Right End of Structure, 3.2.4b

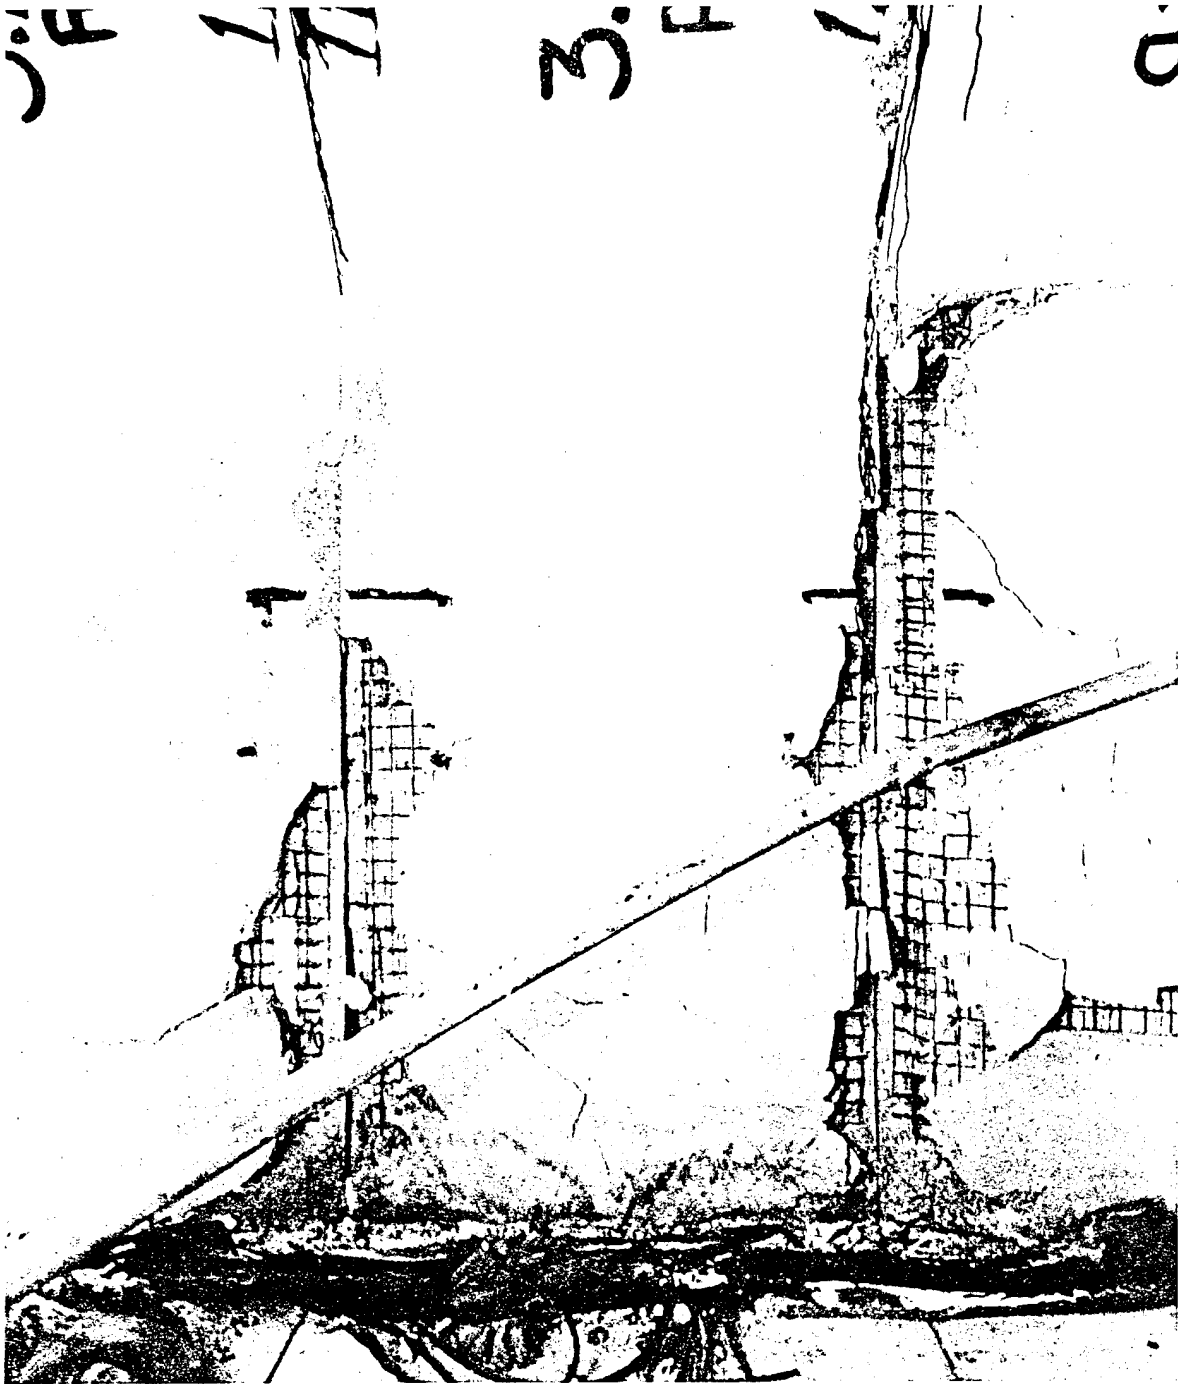
Fig. L.356 Interior View of Ribs-out Panel Second from Right End of Structure, 3.2.4b

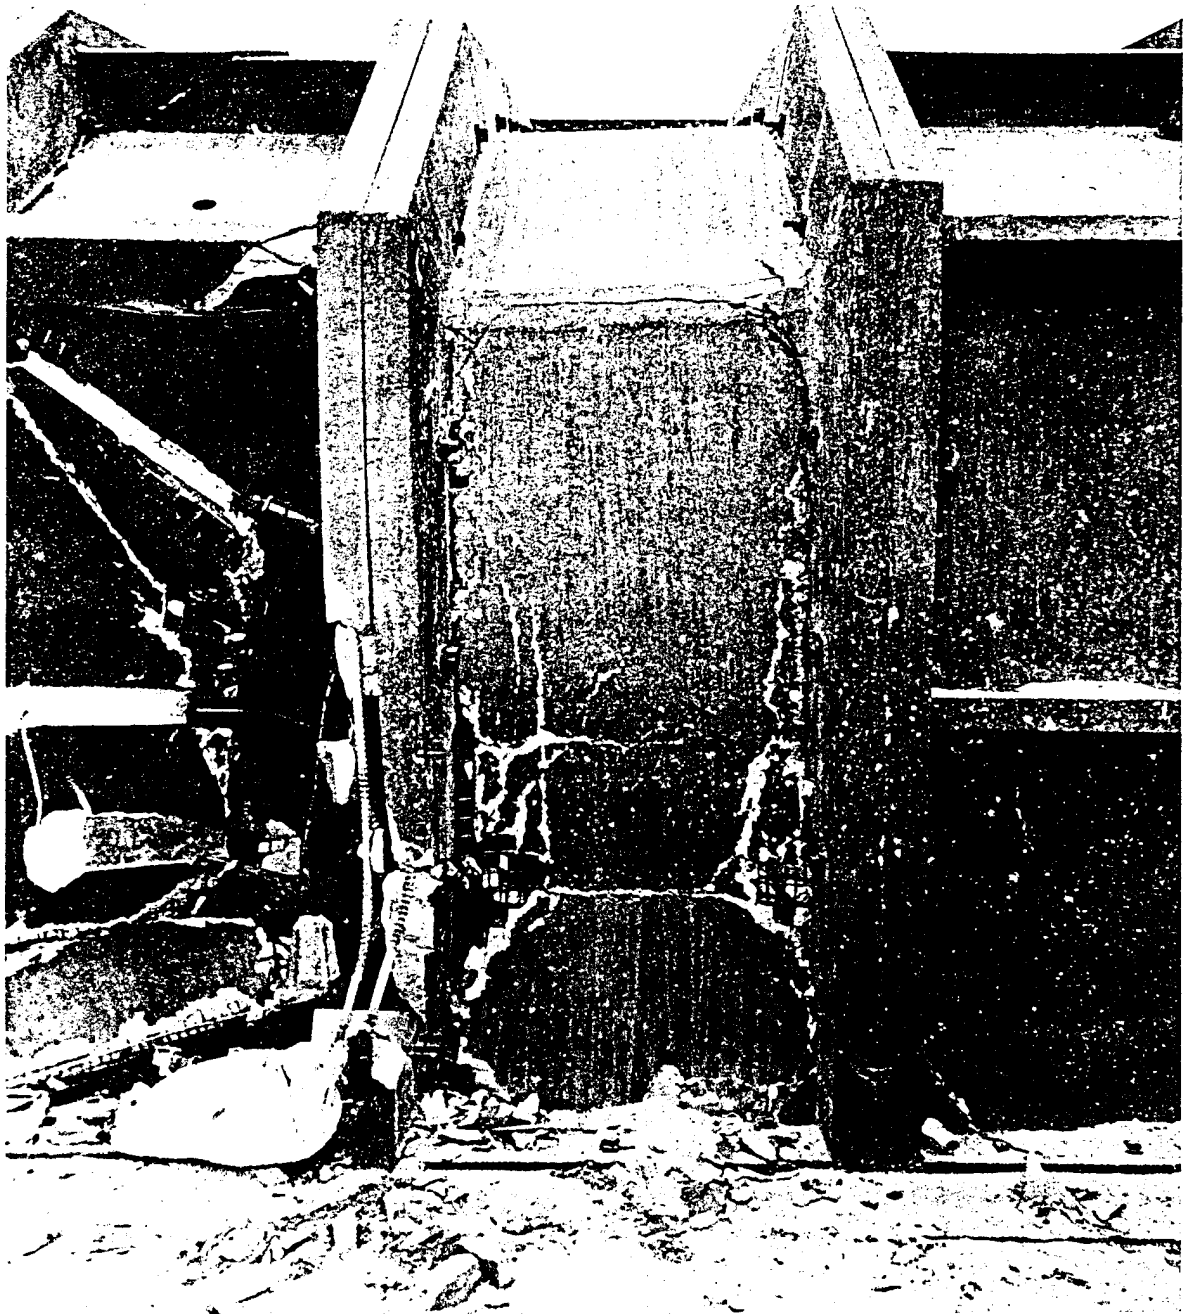
Fig. L. 357 Exterior View of Ribs-out Panel Third from Right End of Structure, 3.2.4b

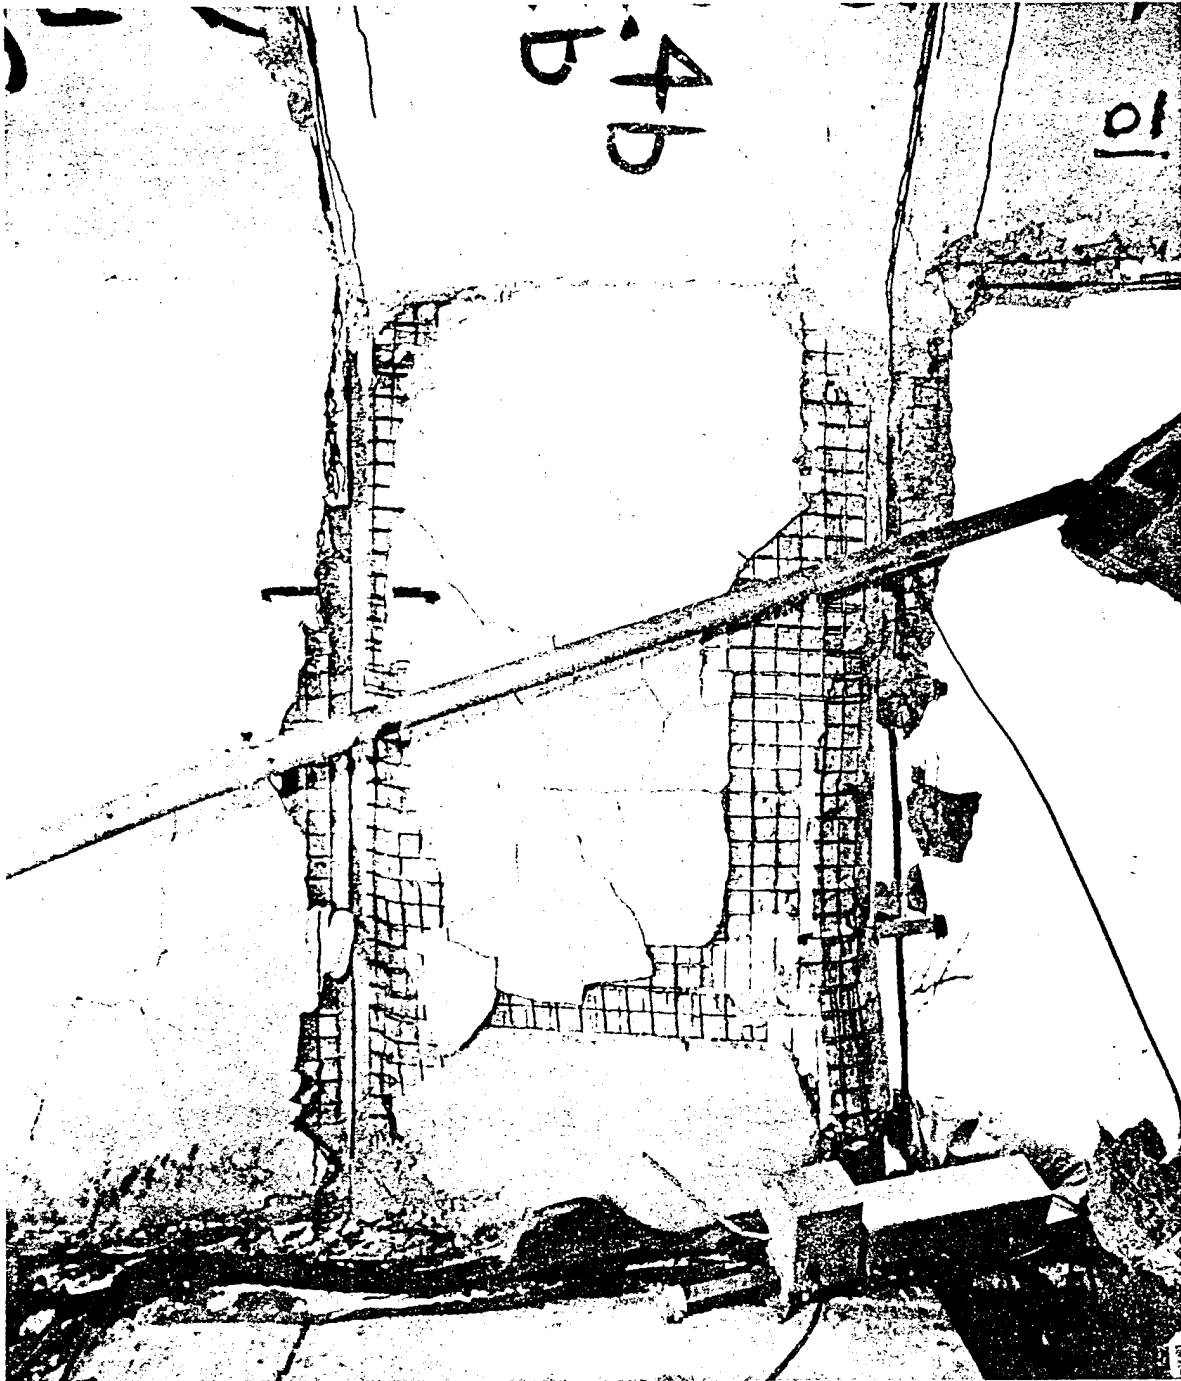
Fig. L.358 Interior View of Ribs-out Panel Third from Right End of Structure, 3.2.4b

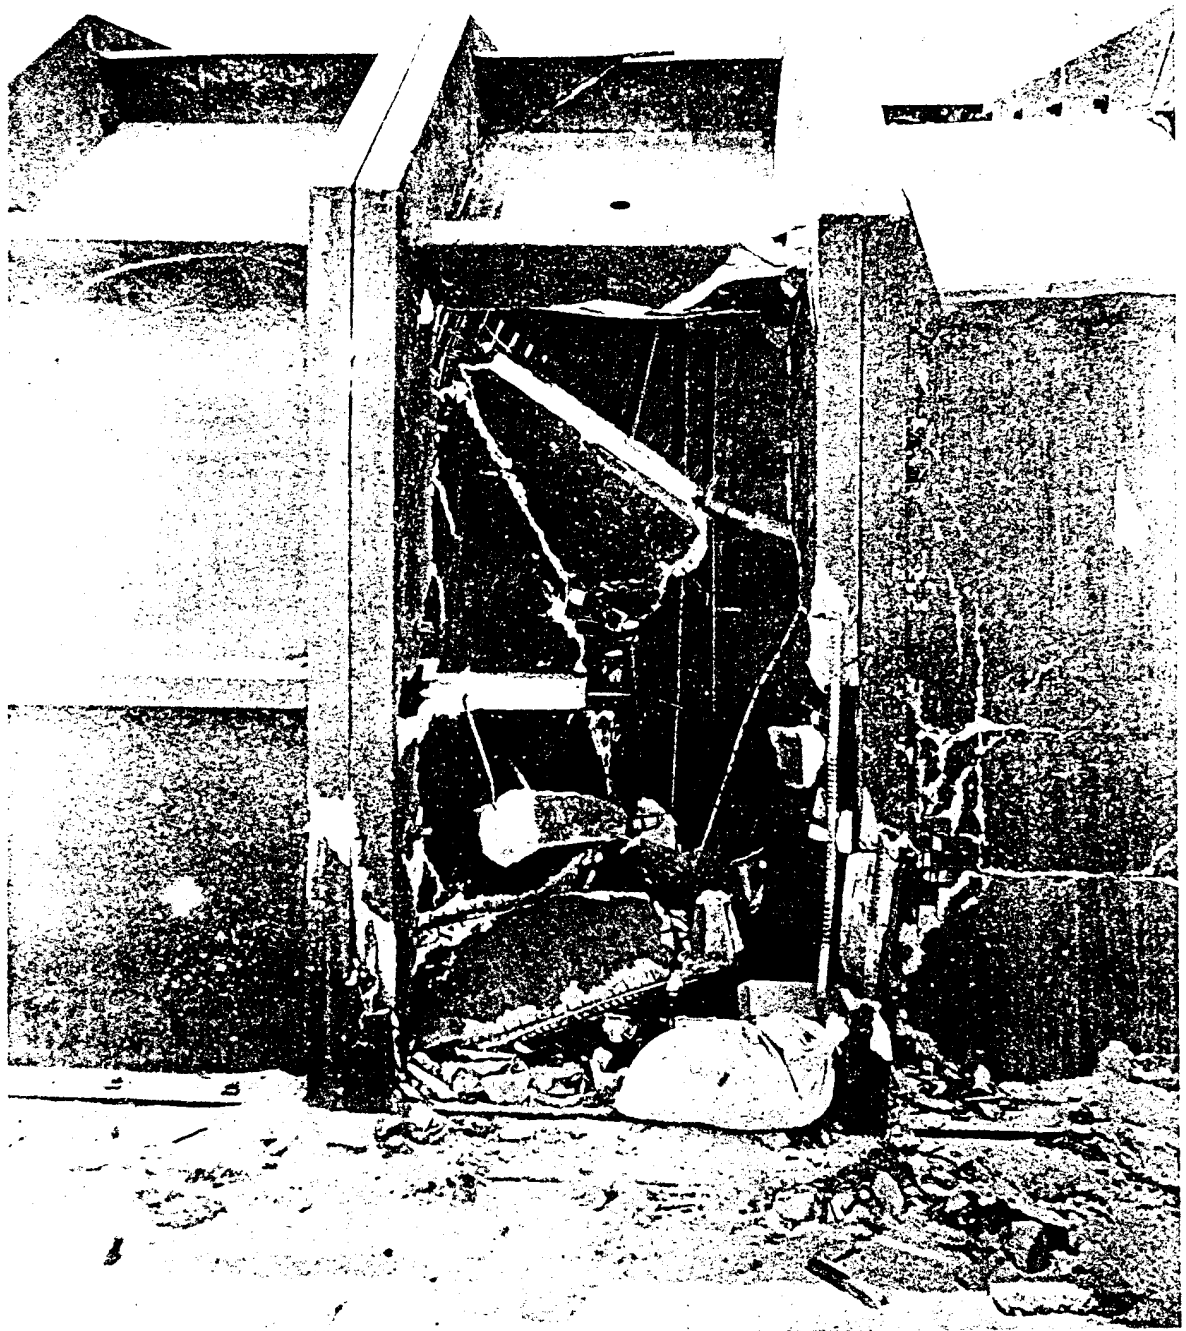
Fig. L. 359 Exterior View of Ribs-out Panel Fourth from Right End of Structure, 3.2.4b

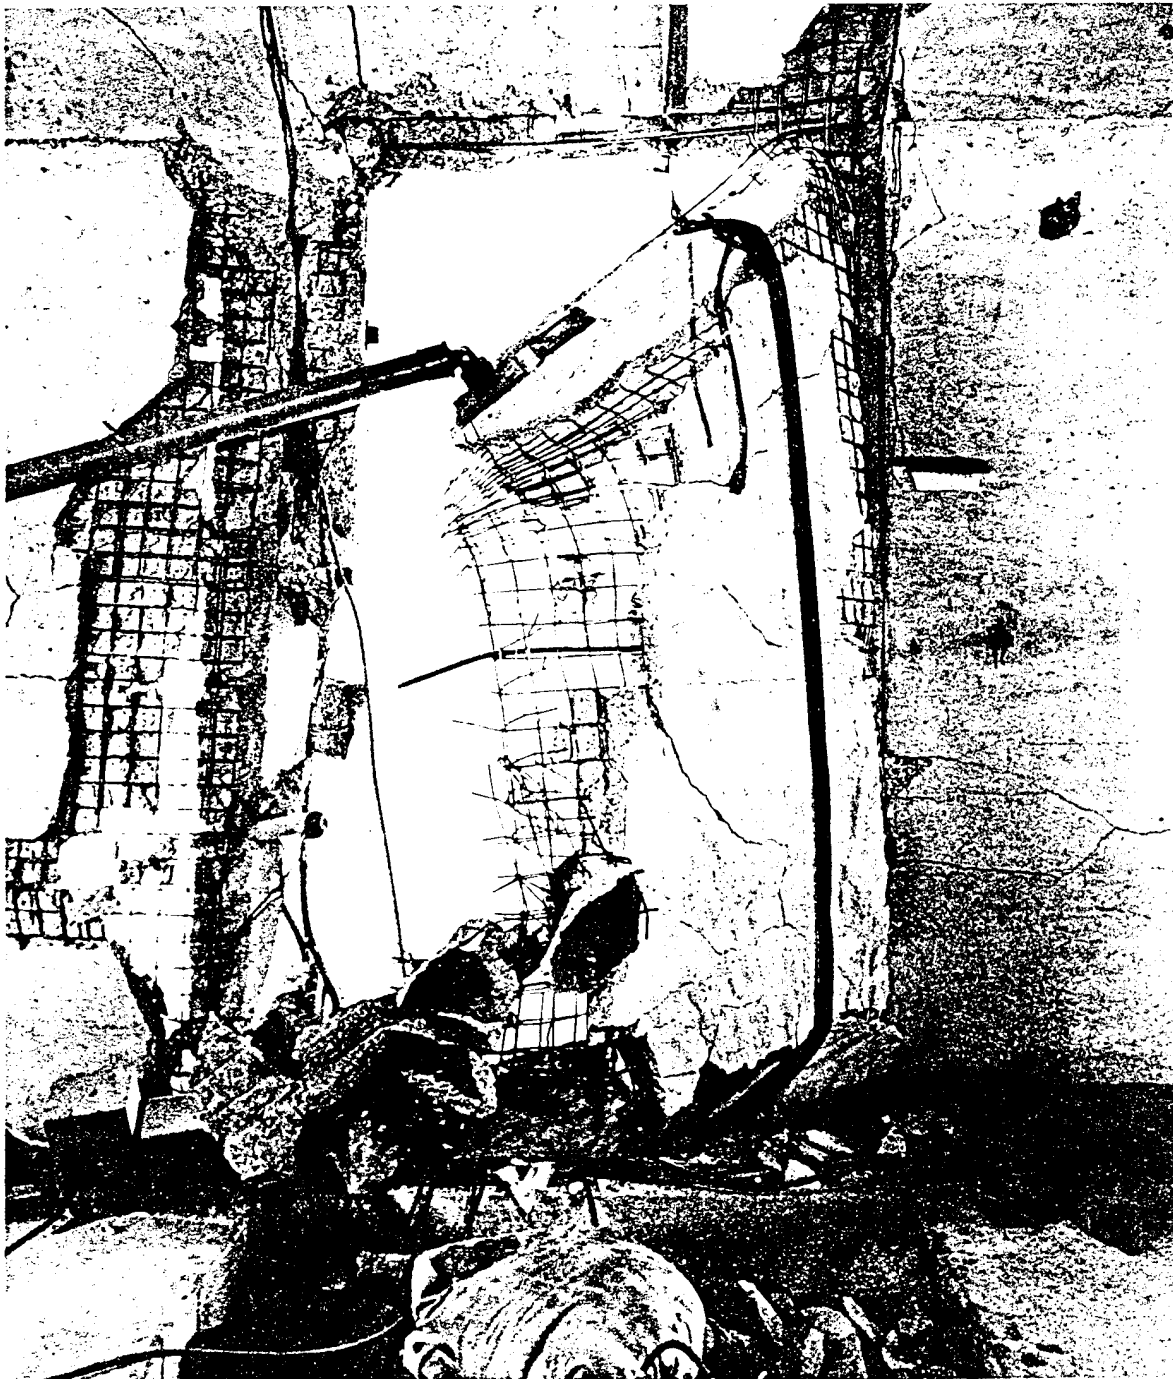
Fig. L.360 Interior View of Ribs-out Panel Fourth from Right End of Structure, 3.2.4b

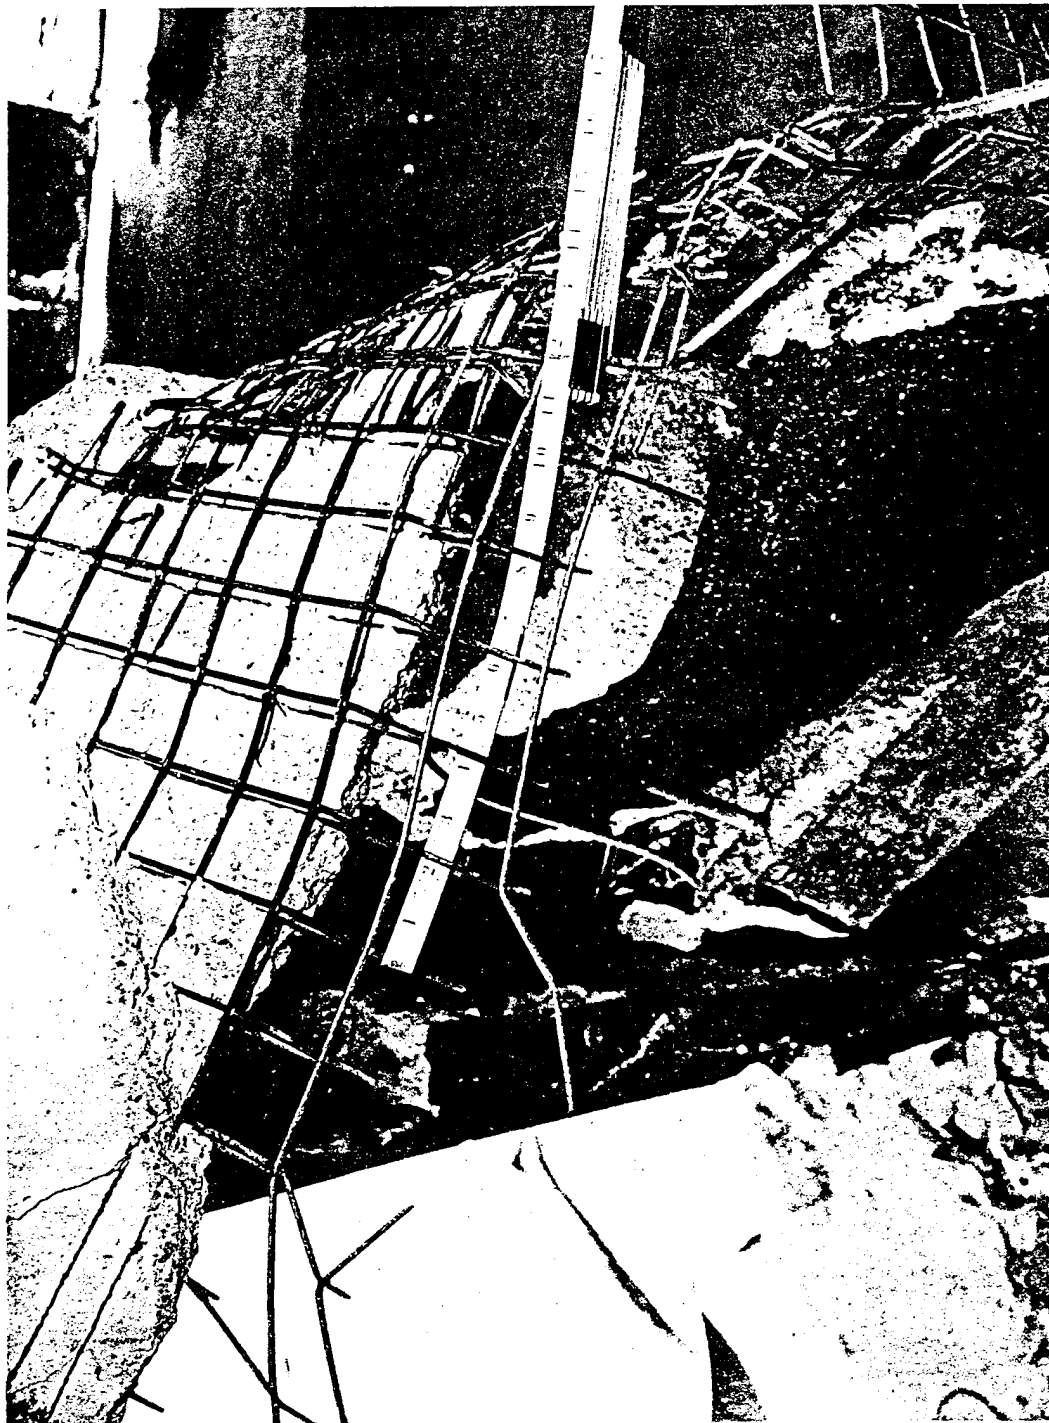
Fig. L. 361 Interior Detail of Rib and Mesh Failure of Ribs-out Panel Fourth from Right End, Structure 3.2.4b

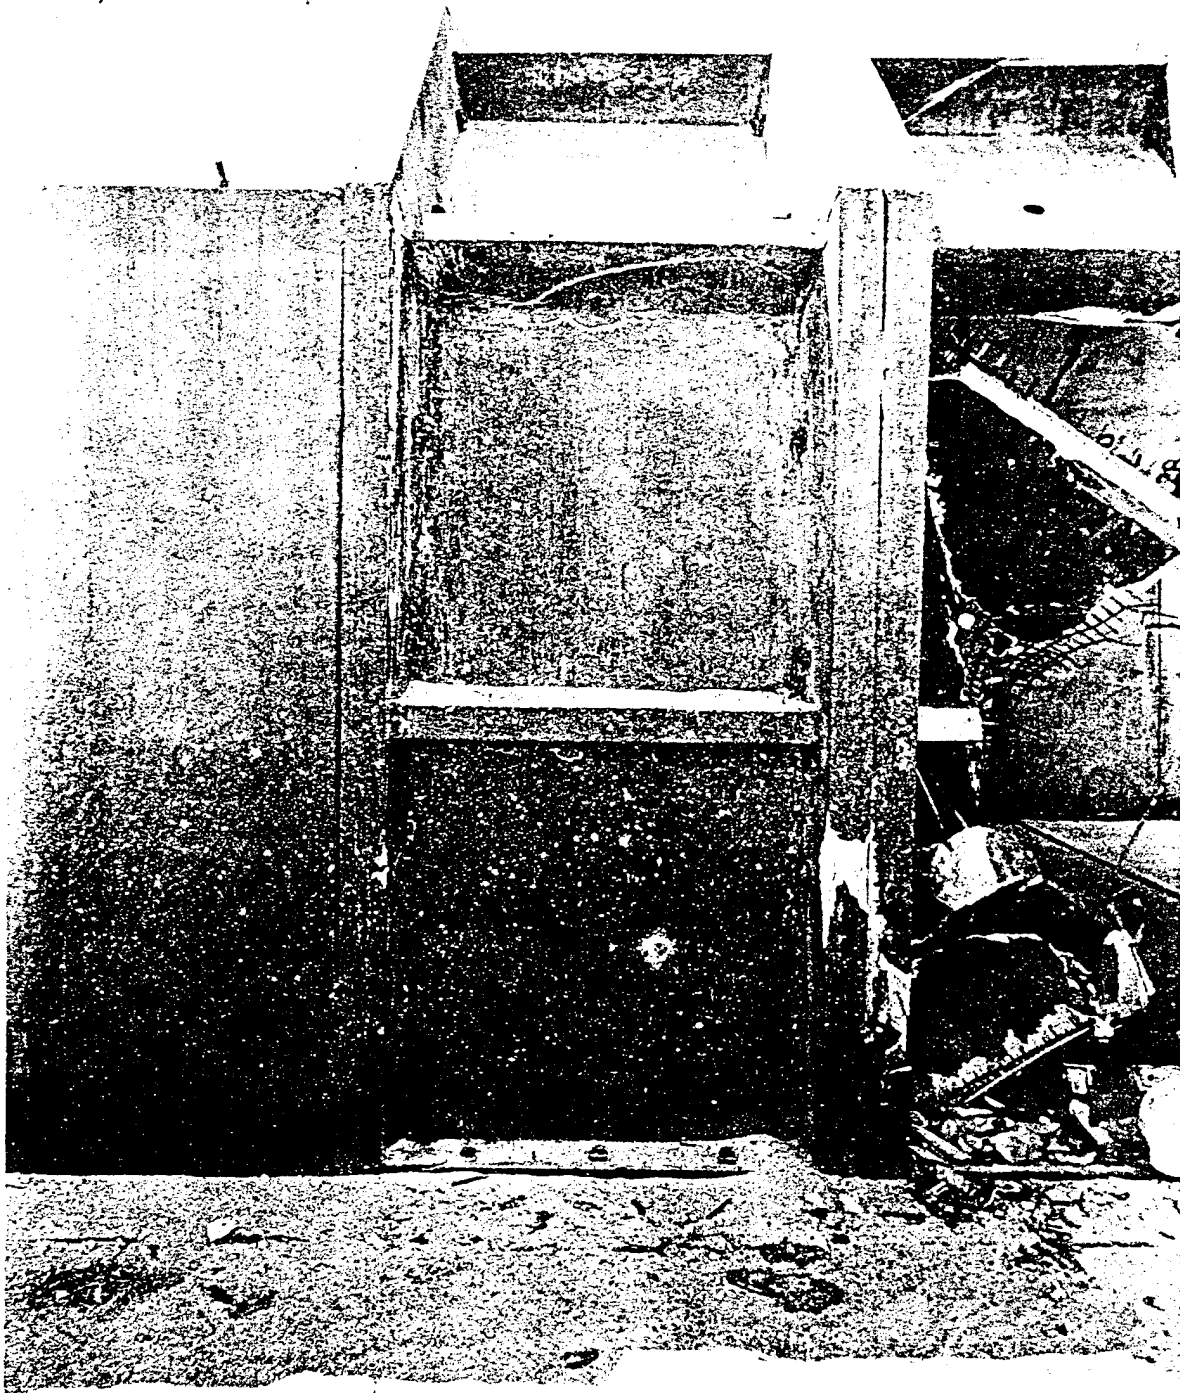
Fig. L.362 Exterior View of Ribs-out Panel Fifth from Right End of Structure, 3.2.4b

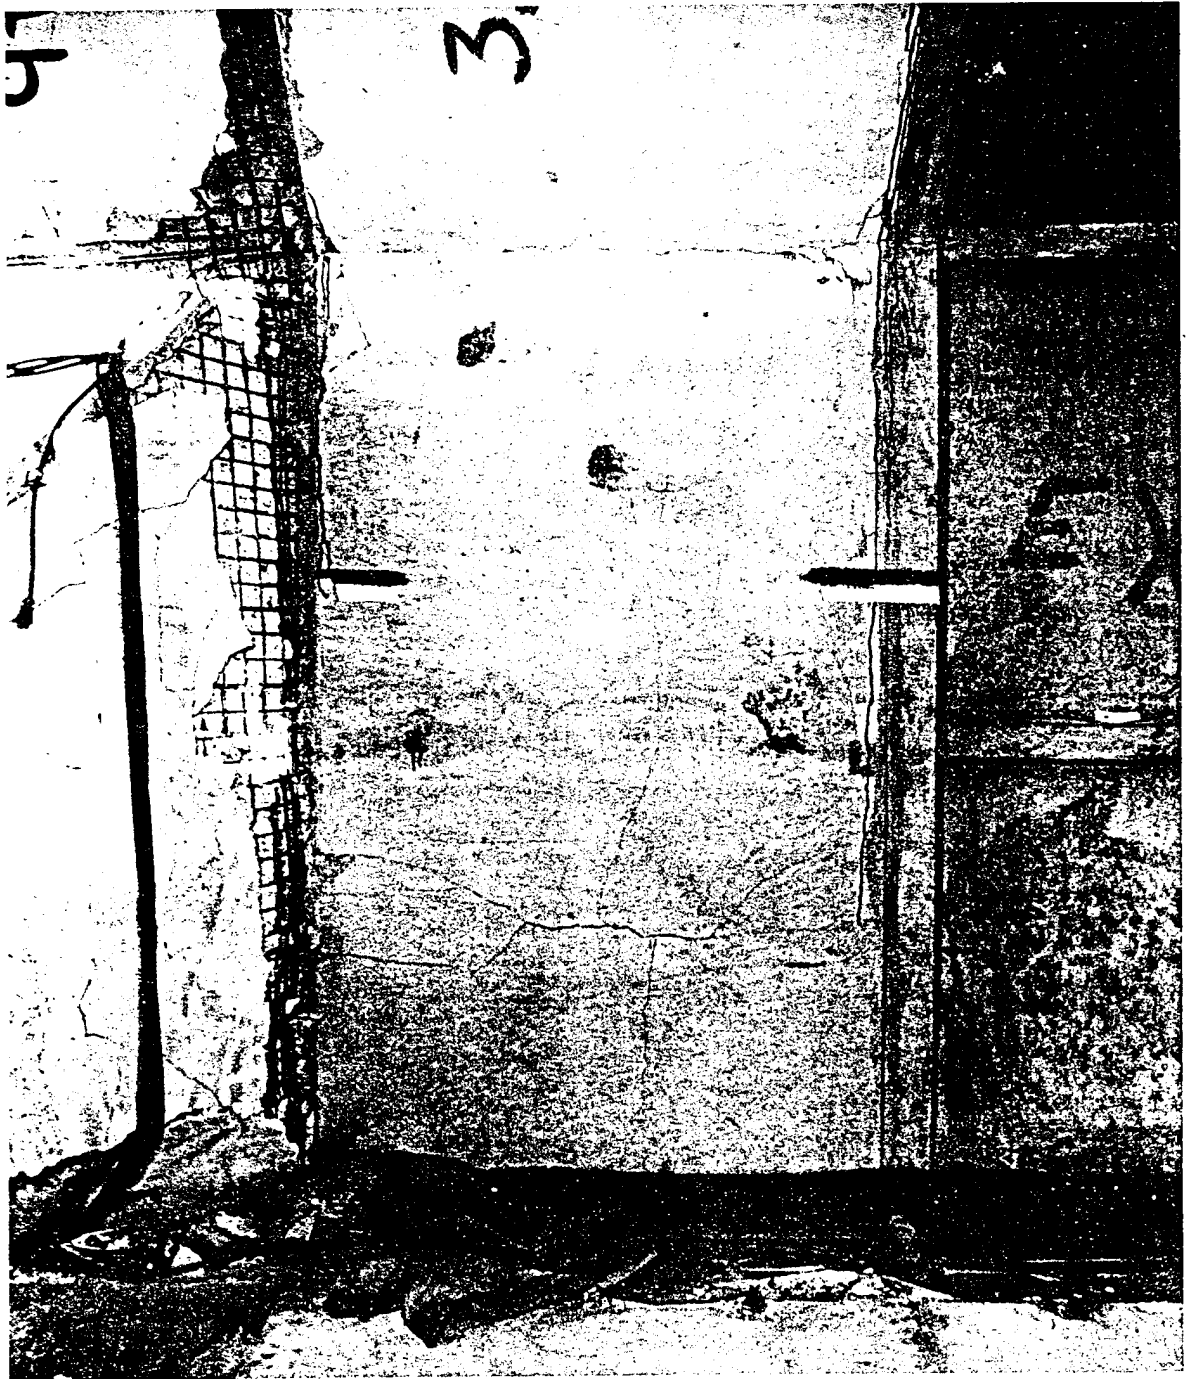
Fig. L.363 Interior View of Ribs-out Panel Fifth from Right End of Structure, 3.2.4b

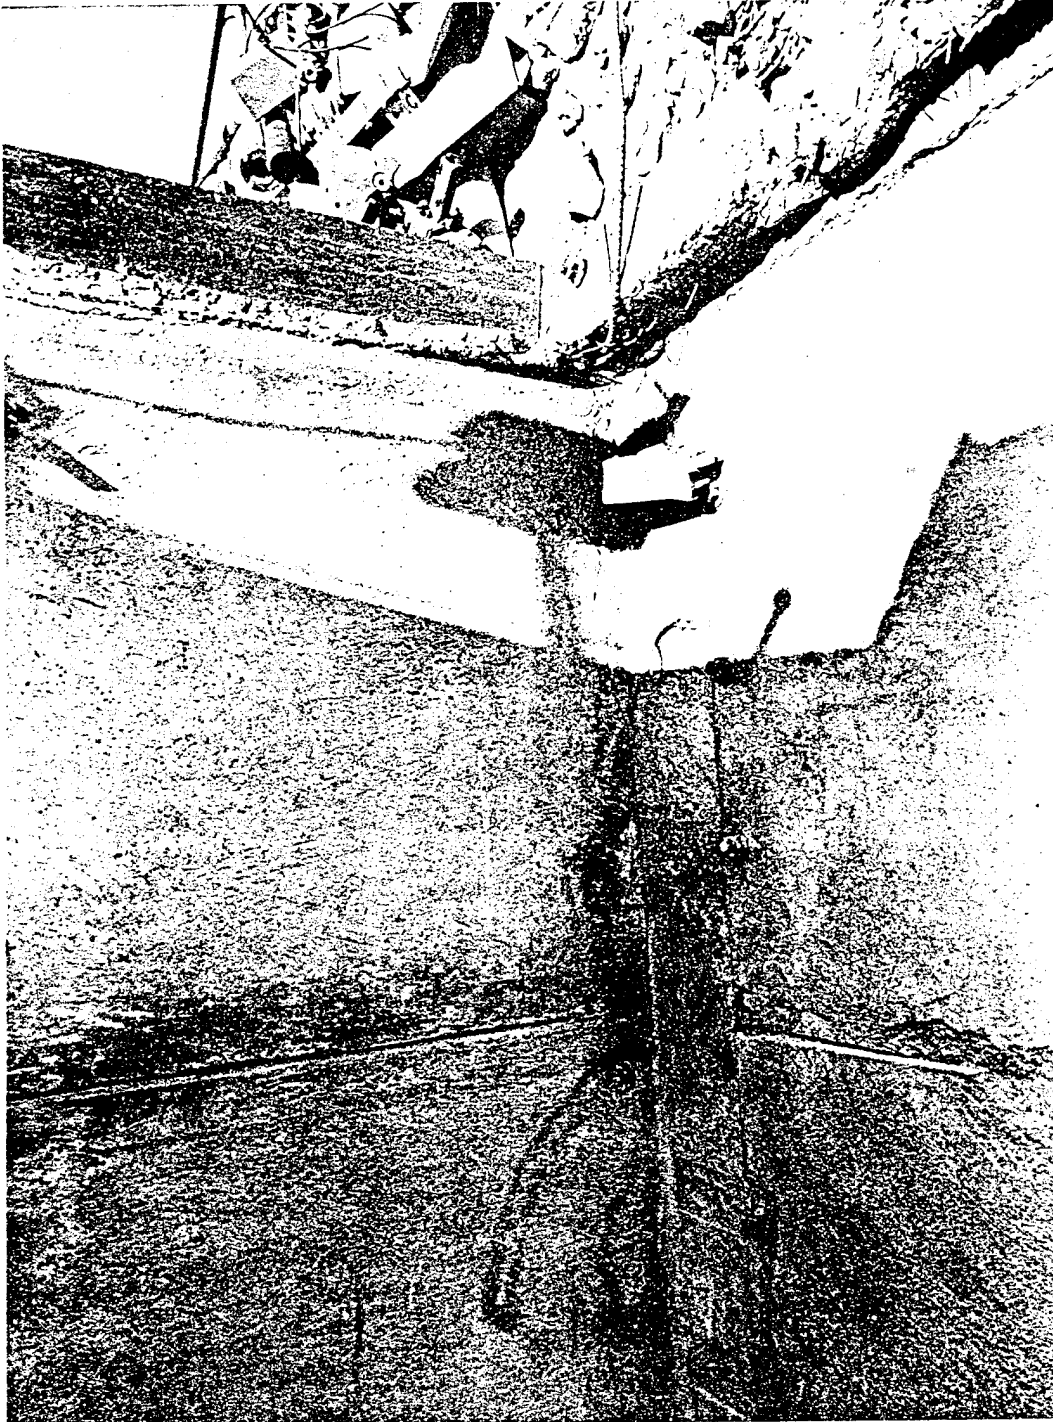
Fig. L. 364 Typical Cracks at the Interior Base of Ribs-out Panels in the Rear Wall, Structure 3.2.4b
